Contract #: 04-0120F4Cty: SF/ALA Rte: 80 PM: 13.2/13.9File #: 99.28**WELDING INSPECTION REPORT****Resident Engineer:**Siegenthaler, Peter**Address:** 333 Burma Road**City:** Oakland, CA 94607**Report No:** WIR-020026**Date Inspected:** 10-Jan-2011**Project Name:** SAS Superstructure**OSM Arrival Time:** 700**Prime Contractor:** American Bridge/Fluor Enterprises, a JV**OSM Departure Time:** 1900**Contractor:** Zhenhua Port Machinery Company, Ltd (ZPMC), Changxing Island **Location:** SHANGHAI CHINA**CWI Name:** Mr. Zhu Zhong Hai**CWI Present:** Yes No**Inspected CWI report:** Yes No N/A**Rod Oven in Use:** Yes No N/A**Electrode to specification:** Yes No N/A**Weld Procedures Followed:** Yes No N/A**Qualified Welders:** Yes No N/A**Verified Joint Fit-up:** Yes No N/A**Approved Drawings:** Yes No N/A**Approved WPS:** Yes No N/A**Delayed / Cancelled:** Yes No N/A**Bridge No:** 34-0006**Component:** OBG TRIAL ASSEMBLY**Summary of Items Observed:**

WELDING INSPECTION REPORT

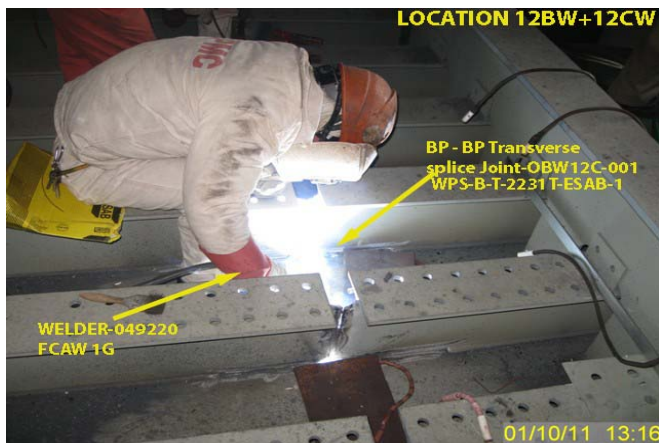
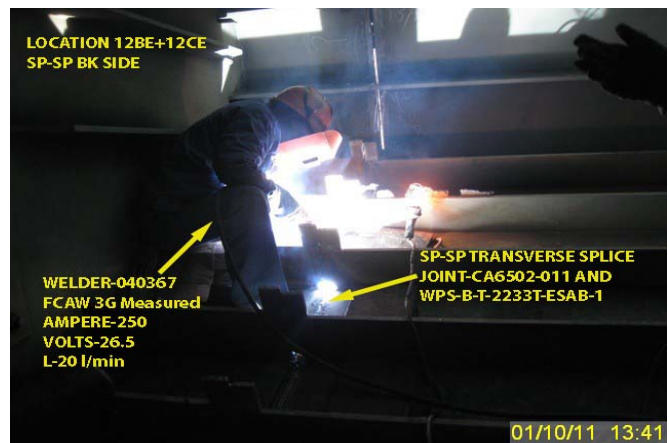
Flux Cored Arc (FCAW) welding of Weld Joint OBW12C-001(12BW+12CW, BP-BP), And Welder is identified as 049220&054460; ZPMC Quality Control (QC) is identified as Mr. Shi Lei. The welding variables appeared to comply with the Applicable WPS-B-T-2231T-ESAB-1.

Flux Cored Arc (FCAW) welding of Weld Joint CA6502-011(12BE+12CE, SP-SP,BK Side), And Welder is identified as 040367; ZPMC Quality Control (QC) is identified as Mr. Li Huajie. The welding variables appeared to comply with the Applicable WPS-B-T-2233T-ESAB-1.

Flux Cored Arc (FCAW) welding of Weld Joint OBE12E-003(12BE+12CE, SP-SP,BK Side), And Welder is identified as 040367&052763; ZPMC Quality Control (QC) is identified as Mr. Li Huajie. The welding variables appeared to comply with the Applicable WPS-B-T-2231T-ESAB-1.

This QA Inspector performed MT of approximately 15% of the area previously tested and accepted by ABF Quality Control personnel. This QA Inspector generated a MT report for this date. The member is identified as OBG 12AW+12BW LD Stiffener Weld area. The weld designations reviewed are as follows.
